## North Coast Regional Water Quality Control Board

SUBJECT: **Inspection Report** for July 19, 2018 Warrant Inspection of Trinity County APN 016-200-17-00.

File: Cannabis Program Inspections, Trinity County, July 2018 WET Inspections, Rodney and Gayle Baker, CIWQS Place ID 849792

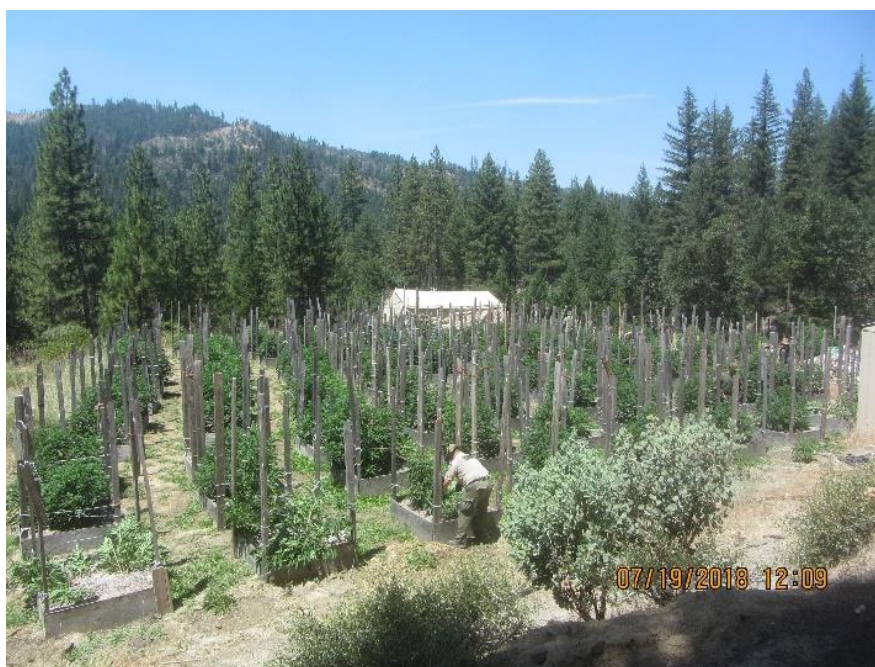
10. **Cultivation-related wastes:** Staff observed cannabis related wastes near cultivation area C2.
11. **Refuse and human waste:** Staff observed refuse at locations where it may enter or be transported into receiving waters. Staff did not observe human waste containment/ disposal systems or facilities on the Property, but did observe evidence of uncontained/uncontrolled human waste discharge near the southeastern edge of the Property.

Photo 3 – Facing west looking at second cultivation site, C2

6. If the property owner and/or tenant(s) choose to continue to cultivate cannabis, enroll for coverage under and take steps to comply with the requirements of the CANGO.

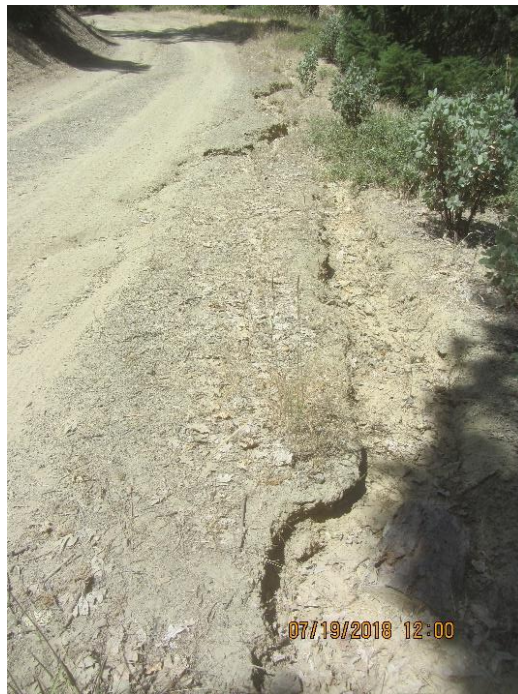
- 1. Site maintenance, erosion control and drainage features:** Staff observed discharges and threatened discharges of sediment to surface waters associated with the main access road.
- 2. Stream crossing maintenance and improvement:** Staff observed a number of drainage swales crossing the road; it appears that the road was constructed through watercourses without installation of stable conveyance for the watercourses.

Photo 5 – Drainage swales on main access road.

measures to ensure that unstable features caused or affected by onsite development and operations are removed or otherwise protected to minimize the potential for these features to cause adverse impacts to water quality and beneficial uses. Dispose of all development and restoration-related earthen spoils in a manner to prevent/minimize transport and delivery to receiving waters. As a reference for the goal of this recommendation, review standard conditions 1, 2, 3, and 4 of the regional cannabis order and relevant portions of the CANGO.

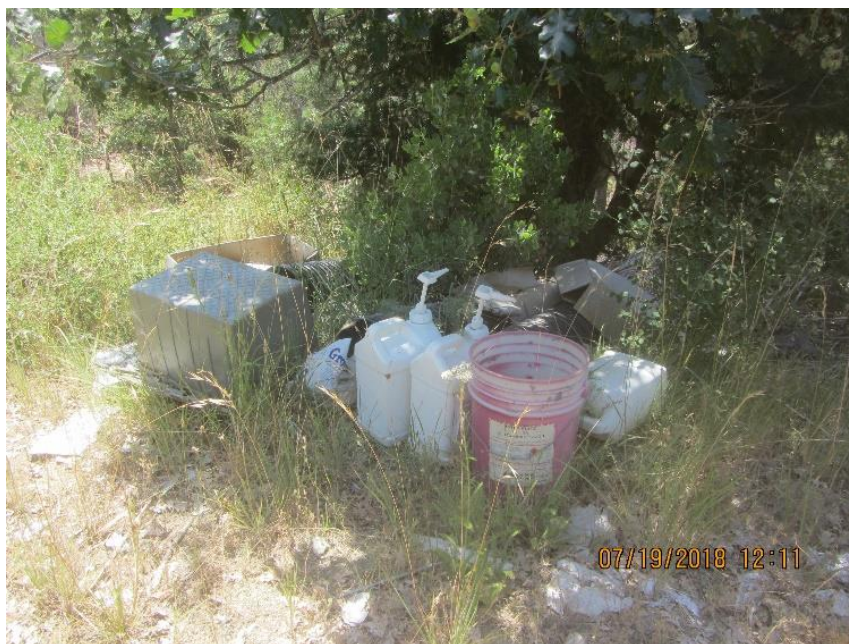
7. **Fertilizers and soil amendments:** Staff observed fertilizer containers at locations where spills or leaks may enter or be transported into receiving waters.

8. **Pesticides:** Staff observed pesticides at locations where they may enter or be transported in receiving waters.
9. **Petroleum products and other chemicals:** Staff observed fuel containers at locations where spills or leaks may enter or be transported into receiving waters.

Photo 6 – Fertilizer/Motor Oil Containers located at southwest corner of ridge near C2

1. Store and contain all chemicals, including petroleum, fertilizer and/or pesticides properly to prevent spillage and discharge to receiving waters. Provide secondary containment for all petroleum products. As a reference for the goal of this recommendation, review standard conditions 7, 8, and 9 of Regional Water Board Order No. R1-2015-0023 (Regional Cannabis Order) and relevant portions of the CANGO (Cannabis General Order). Links to both orders provided below.
2. Retain a licensed professional to inventory, assess, and develop a workplan and schedule to implement measures to ensure that all developed features, roads, watercourse crossings, and cultivation areas throughout the Property are corrected, restored, and/or maintained in conditions that prevent or minimize erosion, sediment transport/delivery, and adverse impacts to water quality and beneficial uses. Include

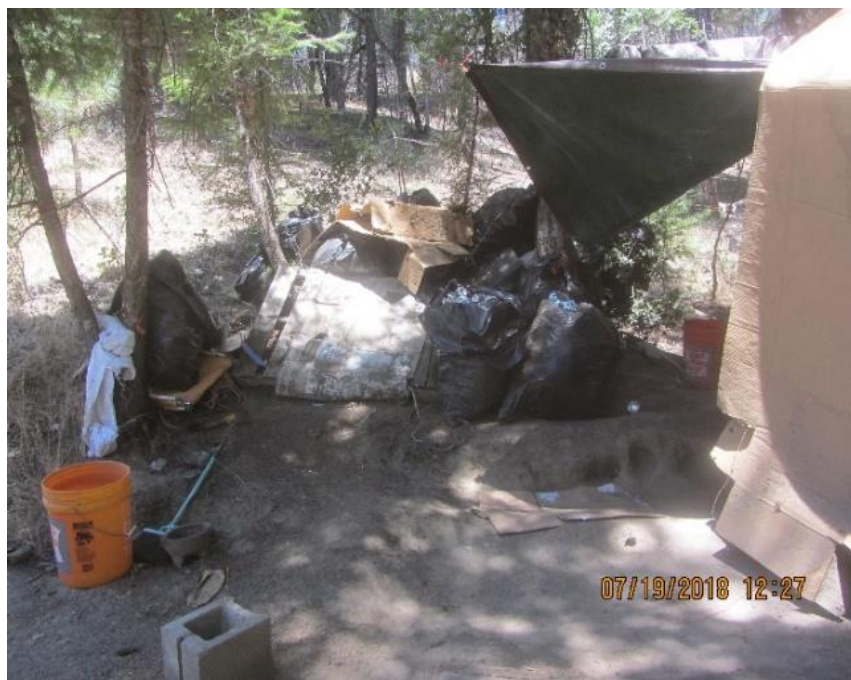
Photo 7 – Trash piles observed near campsite located to the northeast of C1

4. Cease uncontained/uncontrolled discharges of human waste, and develop and implement a short term and longer term/permanent plan for human waste containment and disposal that is protective of water quality and complies with applicable Trinity County requirements.

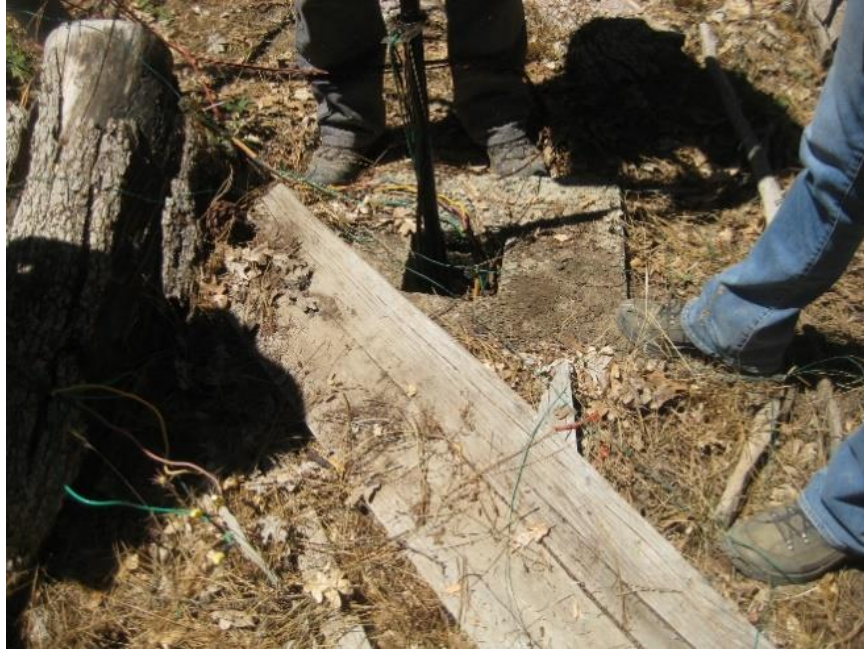
Photo 8- Well located at southwest corner Property.

3. Comply with directives/recommendations provided by the Division of Water Rights and/or the CDFW regarding use/permitting/abandonment of the onsite well. Ensure that well abandonment meets applicable State/County requirements.
